UNITED STATES ENVIRONMENTAL PROTECTION AGENCY
REGION V

RCRA Facility Assessment Summary

Allied-Signal Corporation (UIC)
Danville, Illinois
IID 005 463 344

February, 1990
Robert A. Fuhrer

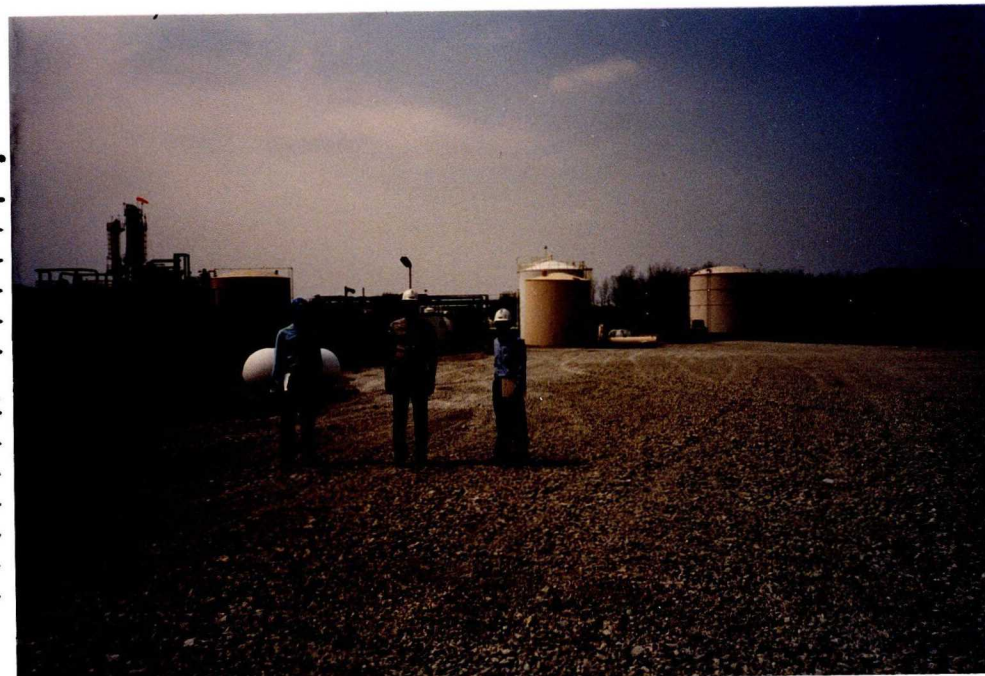
Temporary storage of empty tanks,
"gravel cap"

PROJECT/CASE NO: ILD 005 463 344
SUBJECT: Allied-Signal (VIC)-Danville
LOCATION: Outside Facility, looking West at train yard, in far North portion of the site
CITY: Danville COUNTY: Vermillion STATE: IL
DATE: 4/25/89 TIME: 11:30 A
WEATHER: (SUN) (HAZE) (CLOUDY) (RAIN) (SNOW)
PHOTOGRAPHER (Sig.): Robert A. Fisher
WITNESS: Don Phillips
CAMERA: _____
FILM TYPE: ASA T11 f
NEGATIVE LOCATION: in File FILE #: _____
PROCESSED BY: EPA
PHOTO #: 1 of 18

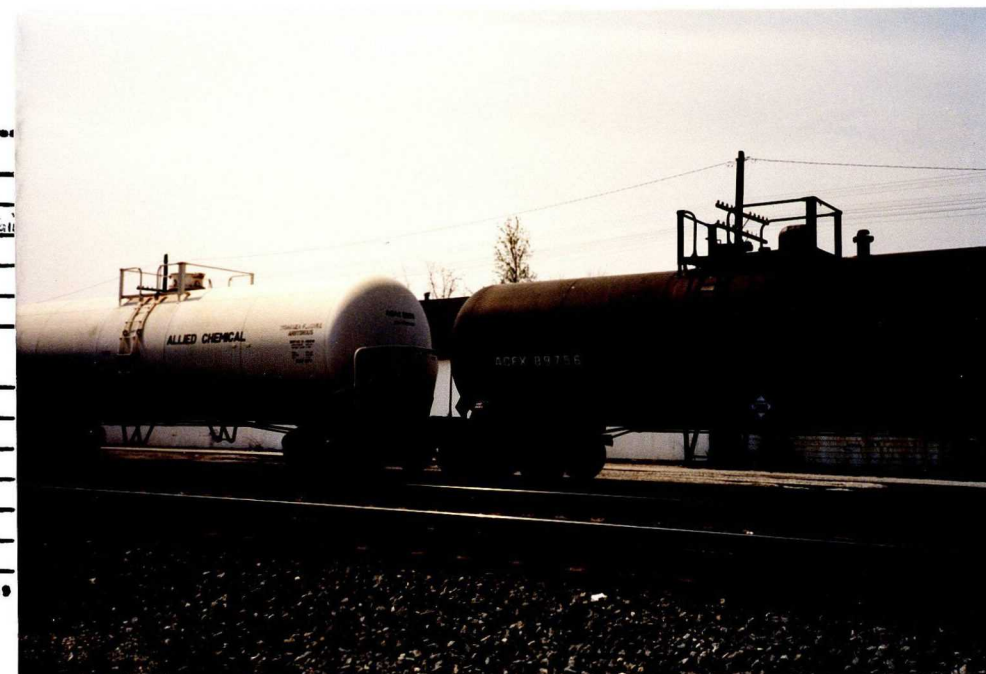
PROJECT/CASE NO: _____
SUBJECT: Allied-Signal
LOCATION: Looking East from capped Residue Pond #3
(MW and train yard in background)
CITY: _____ COUNTY: _____ STATE: _____
DATE: _____ TIME: _____
WEATHER: (SUN) (HAZE) (CLOUDY) (RAIN) (SNOW)
PHOTOGRAPHER (Sig.): _____
WITNESS: _____
CAMERA: _____
FILM TYPE: ASA T11 f
NEGATIVE LOCATION: _____ FILE #: _____
PROCESSED BY: _____
PHOTO #: 5 of 18

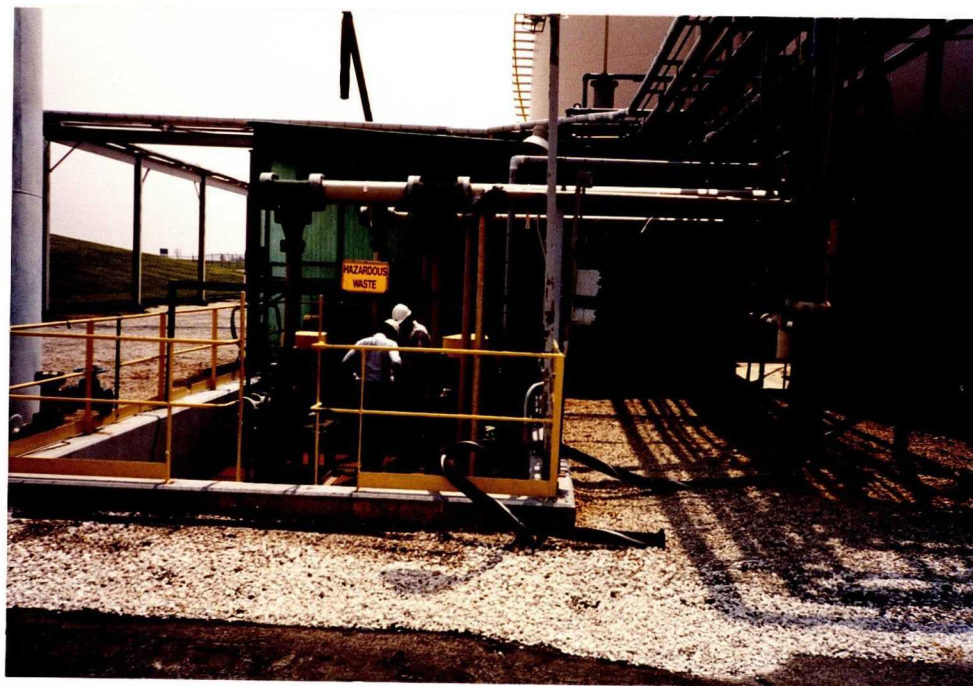
PROJECT/CASE NO: _____
SUBJECT: Allied-Signal
LOCATION: Inside pre injection shed, looking
South, Filtering & pH monitoring, Alarms
CITY: _____ COUNTY: _____ STATE: _____
DATE: _____ TIME: _____
WEATH: (SUN) (HAZE) (CLOUDY) (RAIN) (SNOW)
PHOTOGRAPHER (Sig): _____
WITNESS: _____
CAMERA: _____
FILM TYPE: ASA T11 F
NEGATIVE LOCATION: _____ FILE #: _____
PROCESSED BY: _____
PHOTO #: 9 of 18

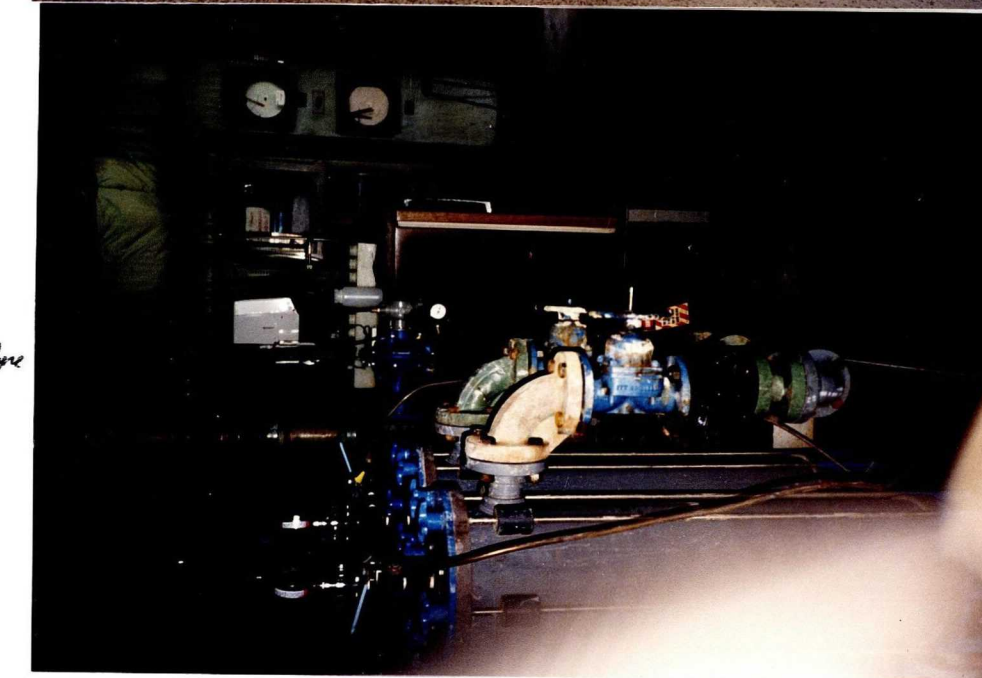
PROJECT/CASE NO: ILD 005 463 344
SUBJECT: Allied-Signal VIC
LOCATION: Drip Pan for Acid Unloading Area
Looking North East at Tank CAR
CITY: Danville COUNTY: Vermillion STATE: IL
DATE: _____ TIME: _____
WEATHER: (SUN) (HAZE) (CLOUDY) (RAIN) (SNOW)
PHOTOGRAPHER (Sig.): Robert Fisher
WITNESS: Don Philips
CAMERA: _____
FILM TYPE: _____ ASA _____ T.1/ _____ f. _____
NEGATIVE LOCATION: File FILE #: _____
PROCESSED BY: EPA
PHOTO #: 16 of 18
GPO 838-588

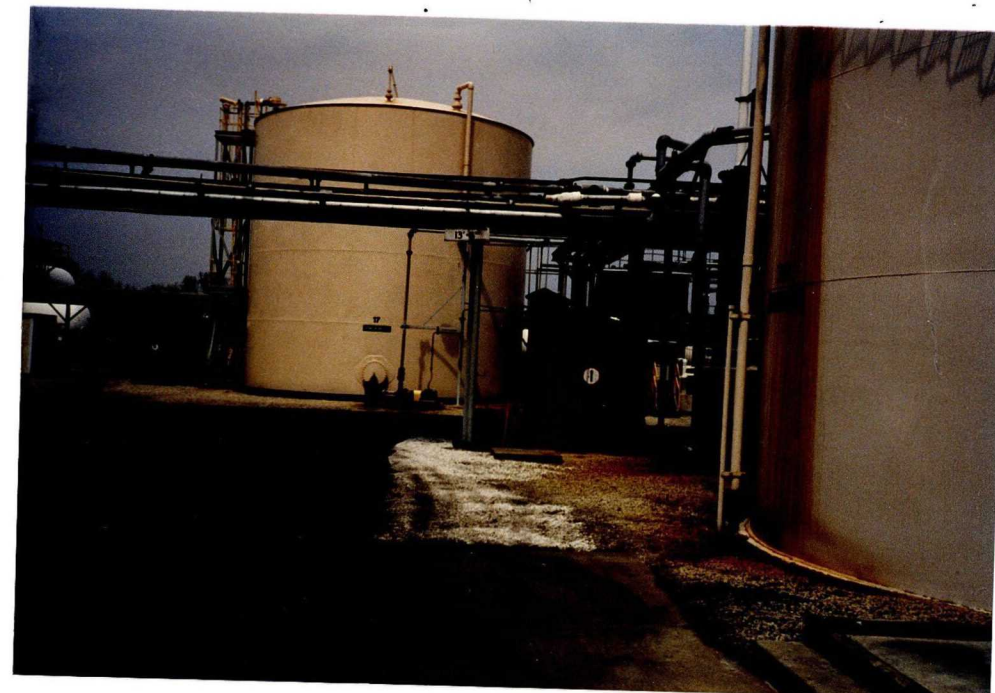
PROJECT/CASE NO: _____
SUBJECT: Allied-Signal
LOCATION: Looking South at "Steel" tank #33
this is HCL waste water and not supposed to be.
CITY: _____ COUNTY: _____ STATE: _____
DATE: _____ TIME: _____
WEATHER: (SUN) (HAZE) (CLOUDY) (RAIN) (SNOW)
PHOTOGRAPHER (Sig.): _____
WITNESS: _____
CAMERA: _____
FILM TYPE: _____ ASA _____ T.1/ _____ f. _____
NEGATIVE LOCATION: _____ FILE #: _____
PROCESSED BY: _____
PHOTO #: 17 of 18
GPO 838-588

Hazardous Waste Processes at Allied at one time included: containerized storage area (S01), acid waste storage tanks and waste collection sump (S02), a deep well injection operation (D79), and a neutralization process (T04). HCL was stored in tanks 33, 34, and 40.

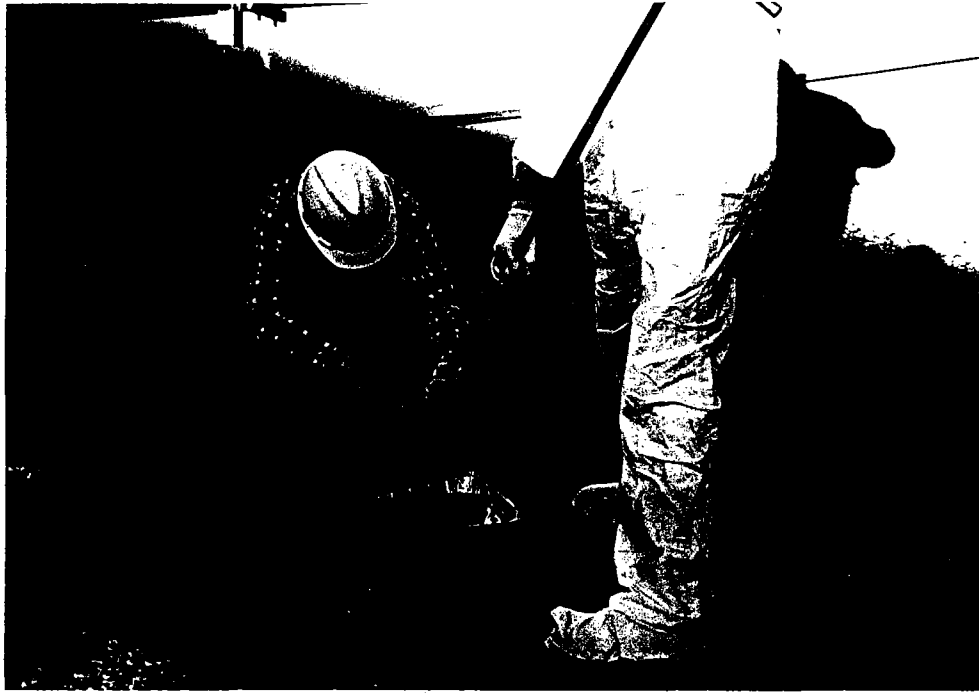
Photo No.: 3

Comments: Sample #5. Versar personnel removing soil from stainless steel auger.

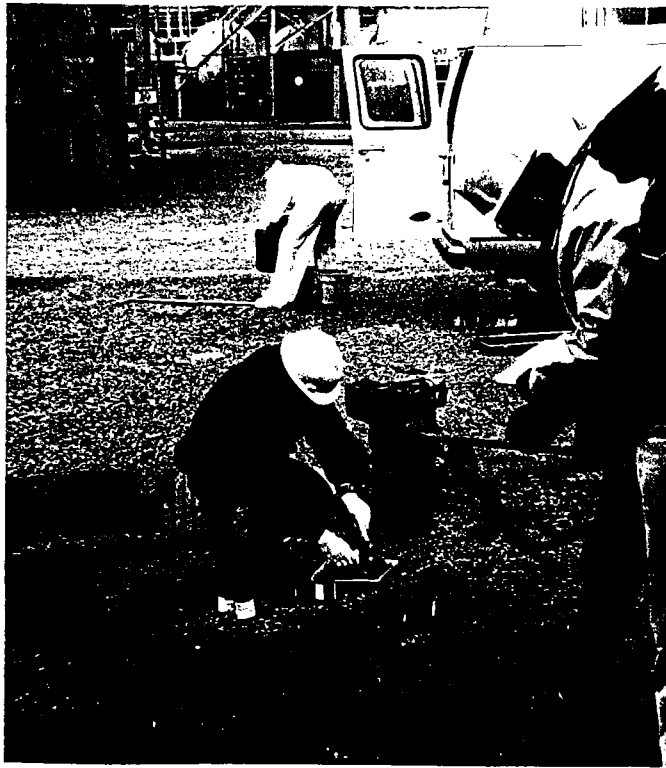
Photo No.: 5

Comments: Sample #8. Versar sampling personnel filling sampling jars with Allied-Signal personnel observing (right). Versar personnel decontaminating stainless steel auger (background).

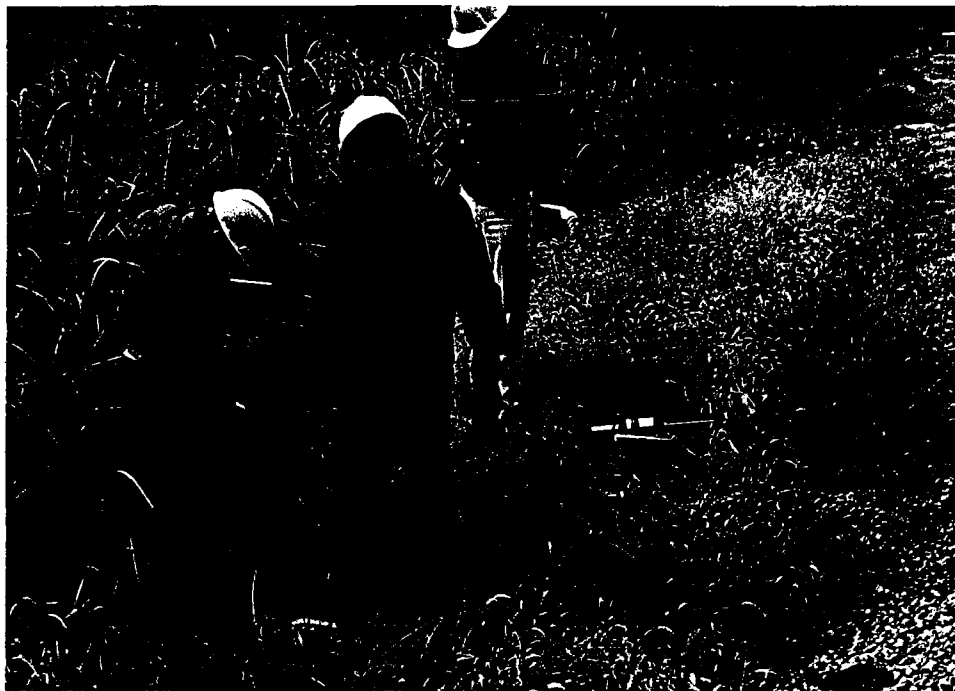
Location: Southwest of SWMU 4

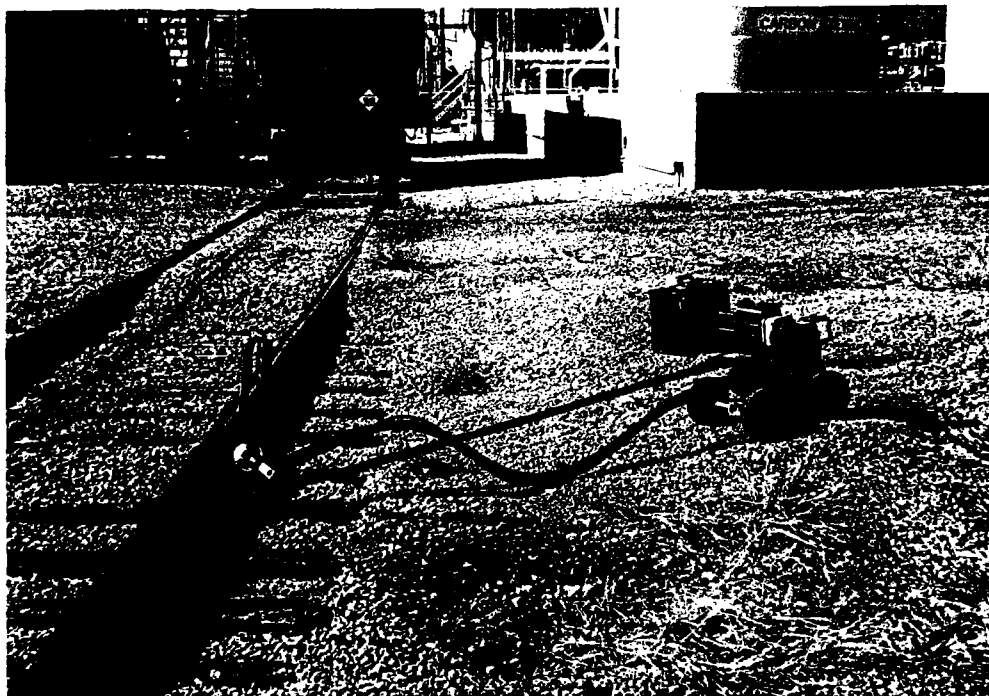
Photo No.: 3

Comments: Sample 3. Picture of augered hole with power auger facing west.

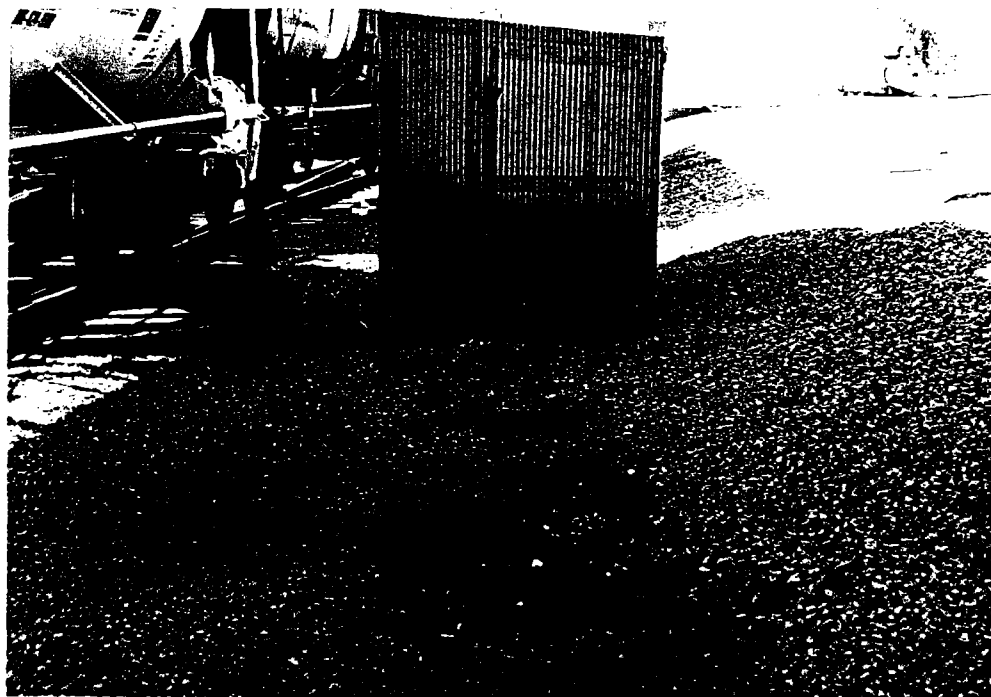
Location: Southwest of SWMU 1

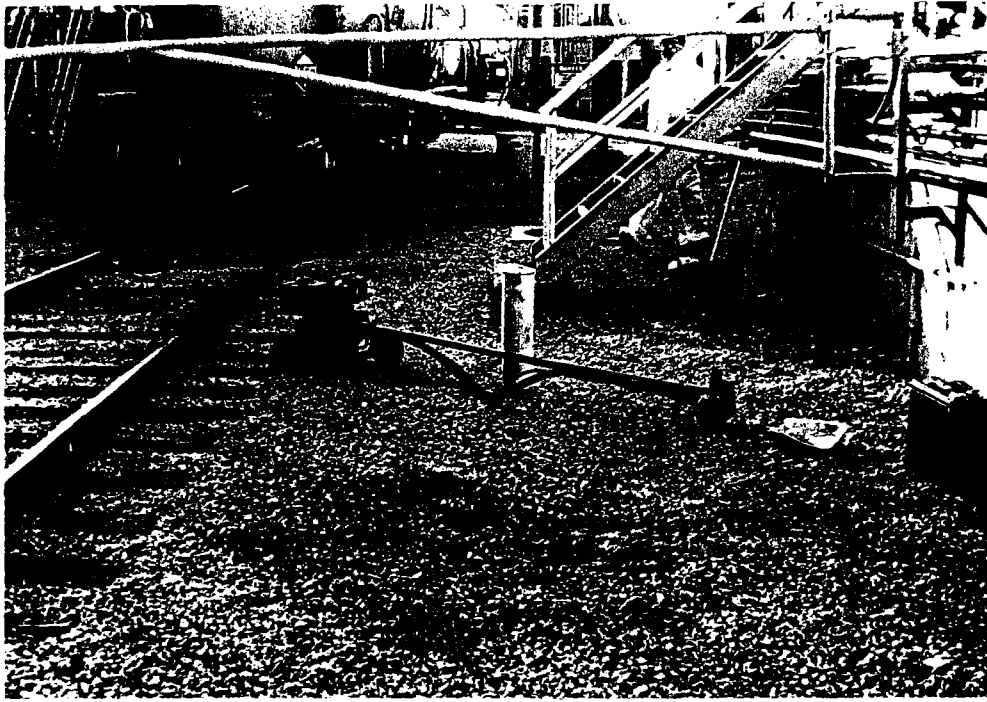
Photo No.: 5

Comments: Sample 5. Picture of augered hole facing west.

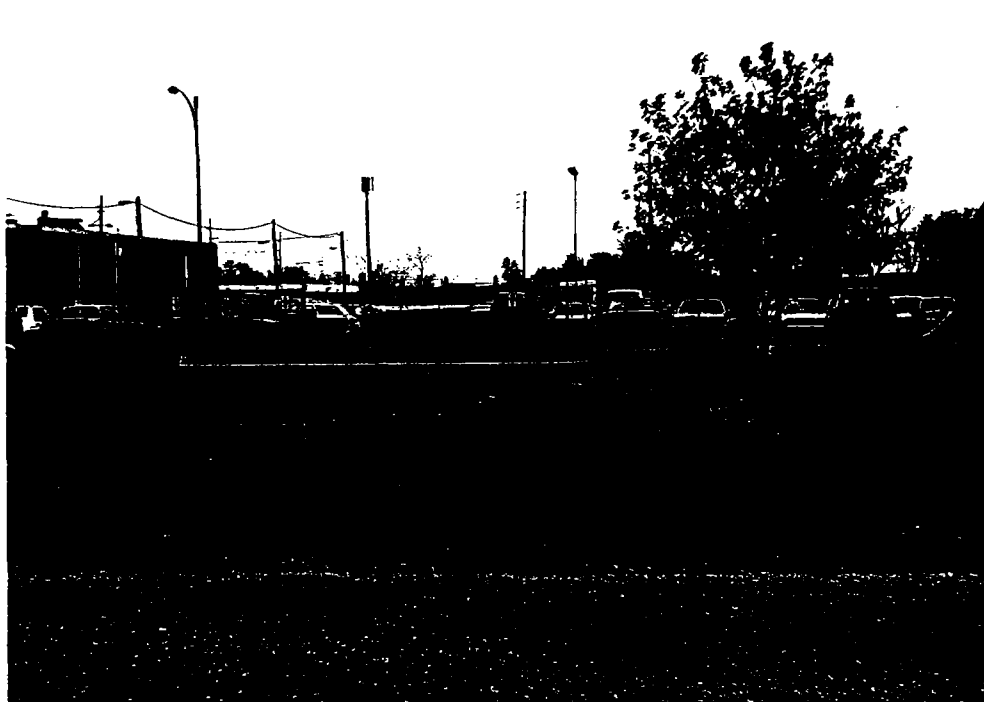
Photo No.: 1	Location: West of facility facing south
--------------	---

Comments: Photo taken after completing sample #1.

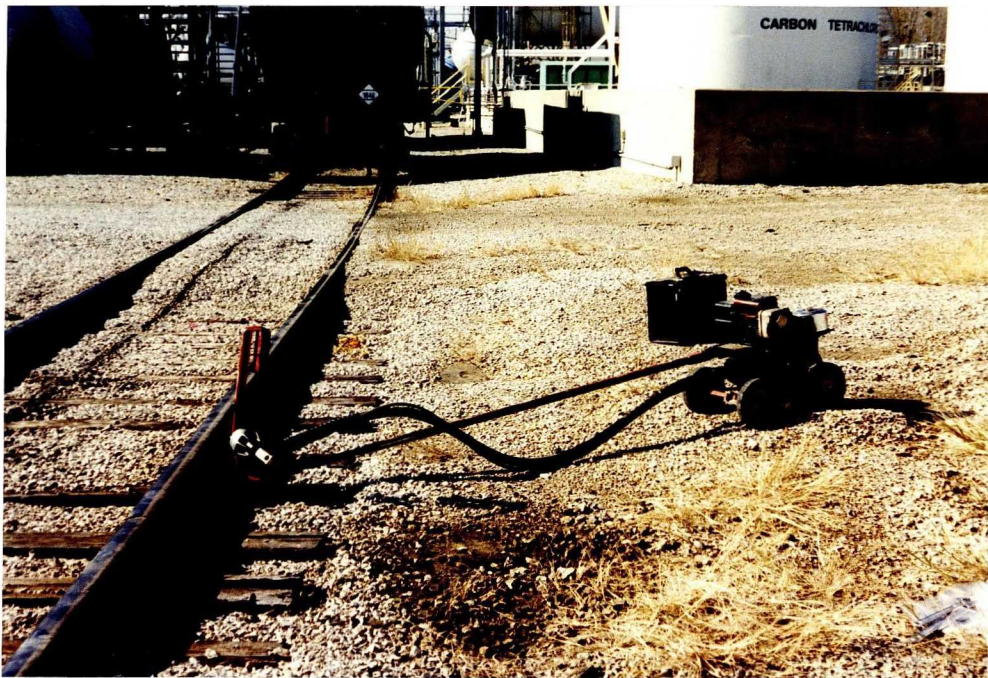
Photo No.: 3	Location: Southwest of SWMU 1
--------------	-------------------------------

Comments: Sample 3. Picture of augered hole with power auger facing west.

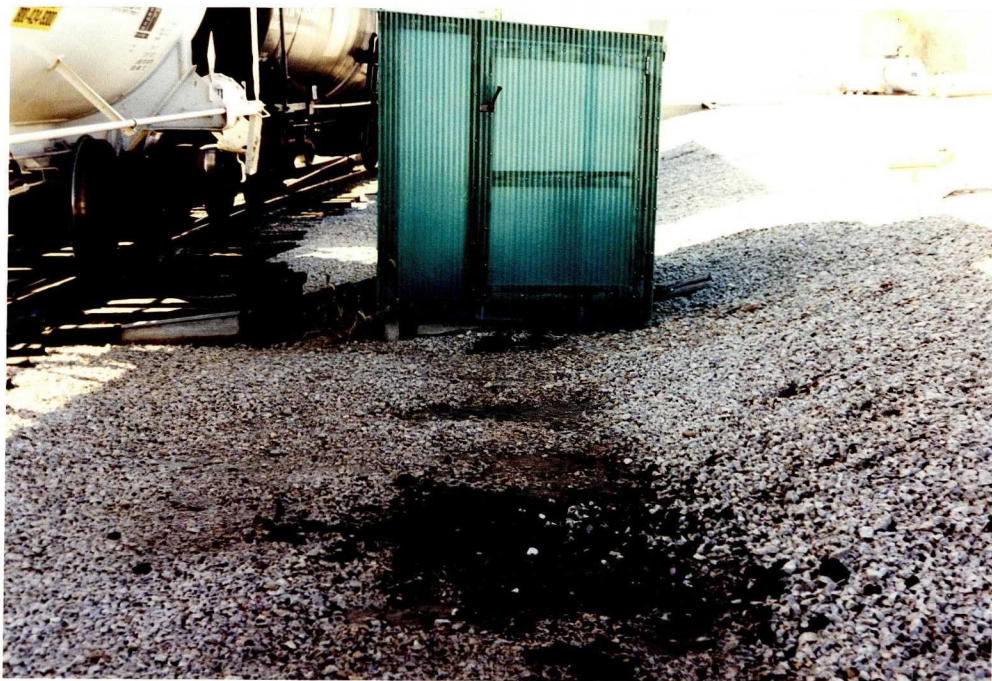
Photo No.: 4	Location: Southeast of SWMU 1
--------------	-------------------------------

Comments: Sample 4. Picture of augered hole facing west.

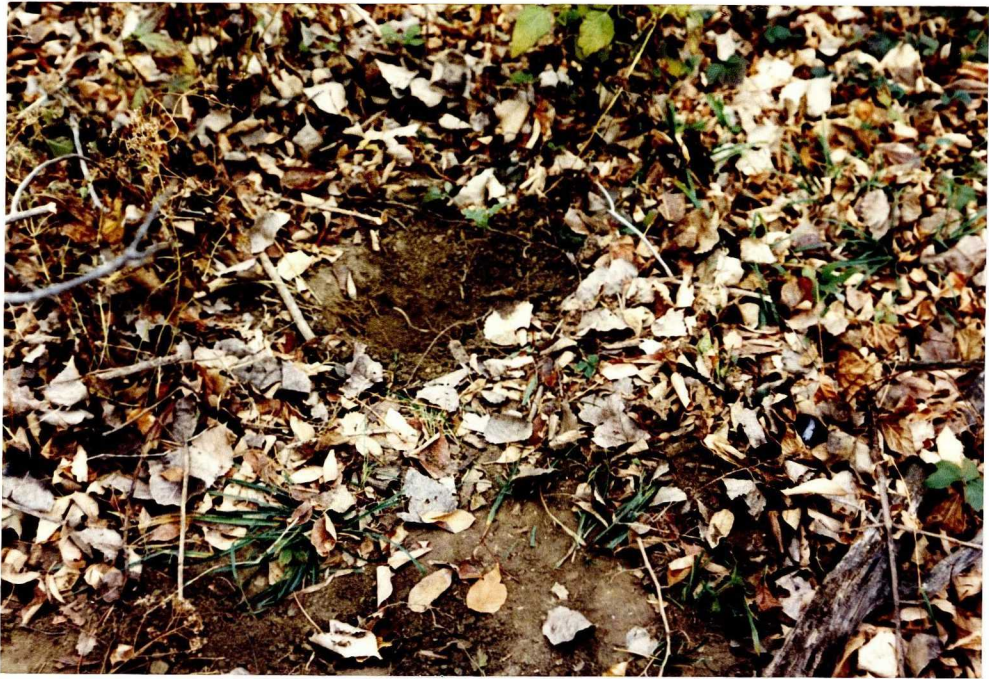
Photo No.: 1	Location: North of Facility
--------------	-----------------------------

Comments: Sample 1. Background; picture of augered hole facing north.

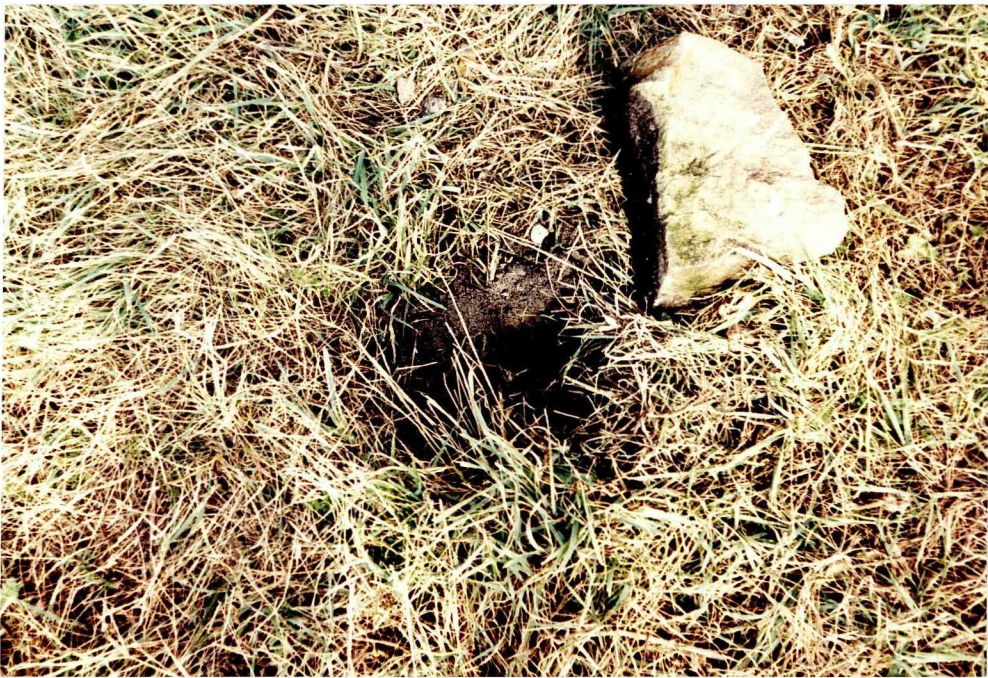
Photo No.: 2	Location: Southwest of Facility
--------------	---------------------------------

Comments: Sample 2. Background; picture of augered hole facing north.

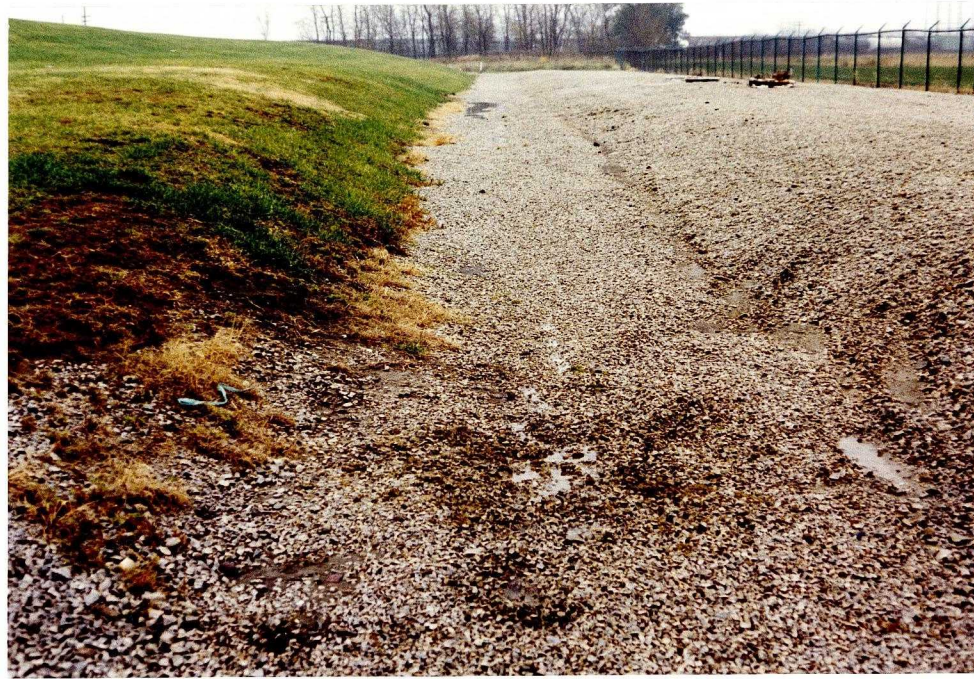
Photo No.: 7	Location: A SWMU 5
--------------	--------------------

Comments: Sample 7. Picture of augered hole facing east.

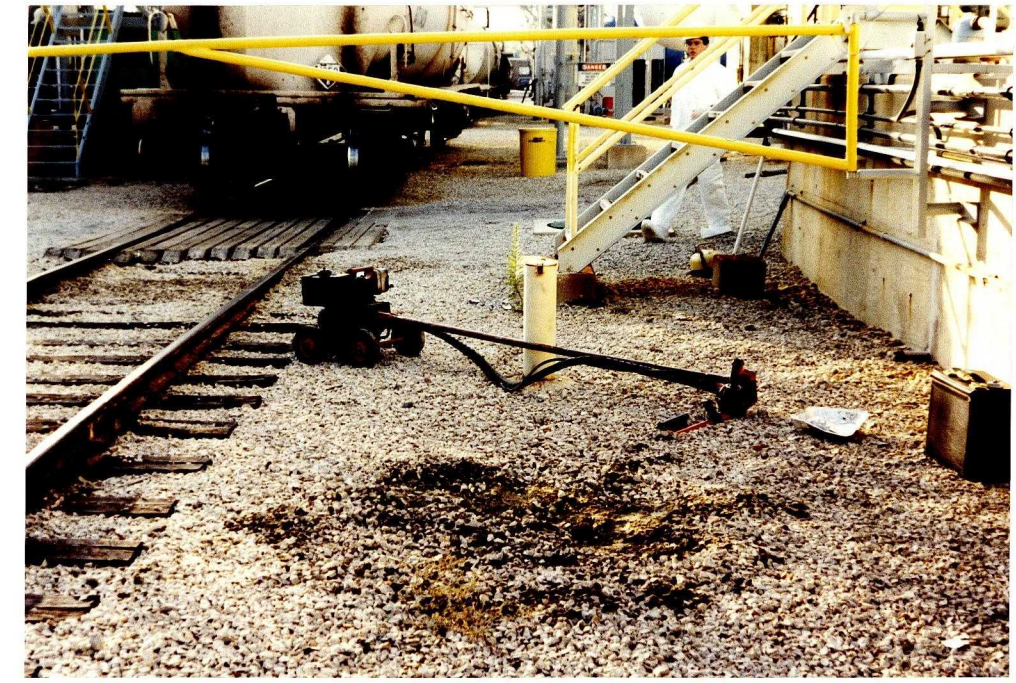
Photo No.: 5	Location: A SWMU 7
--------------	--------------------

Comments: Sample 5. Picture of augered hole facing west.

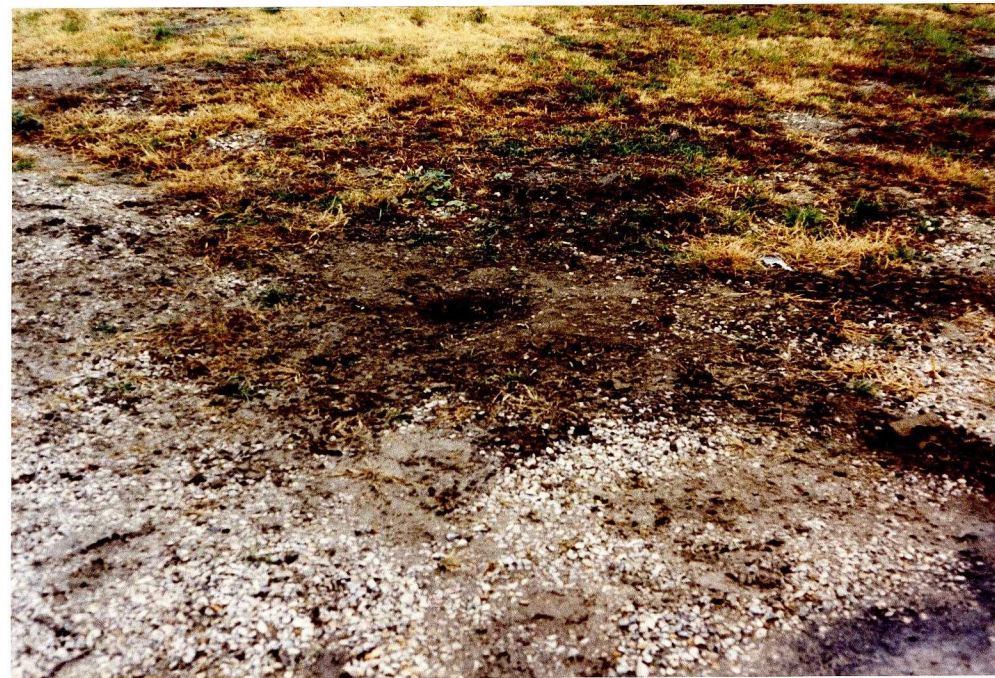
Photo No.: 8	Location: Southwest of SWMU 4
--------------	-------------------------------

Comments: Sample 8. Picture of augered hole facing north.

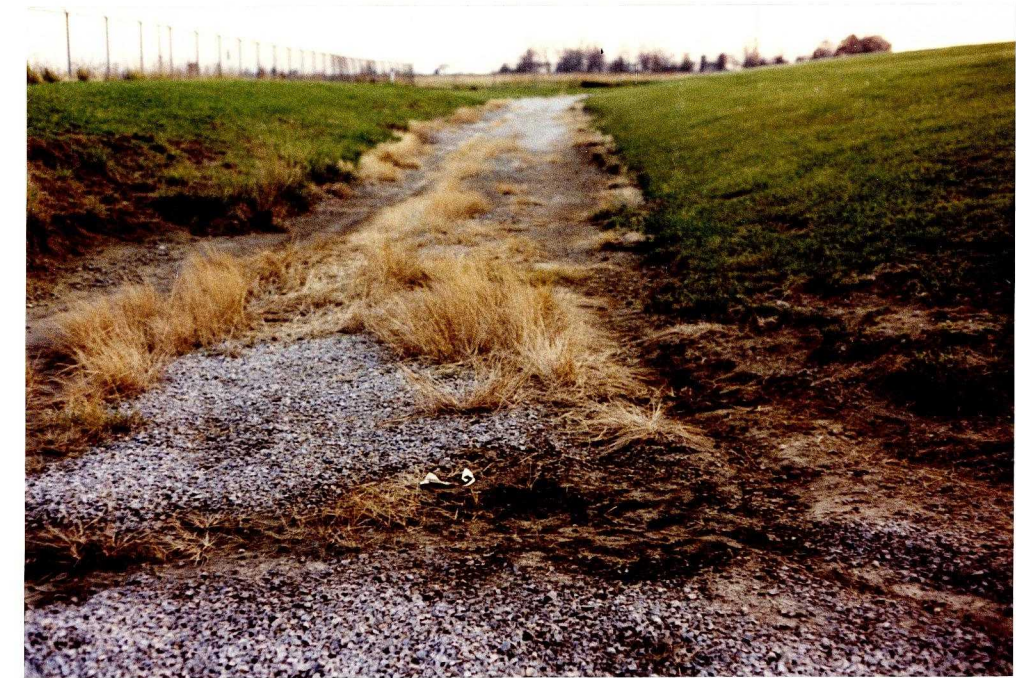
Photo No.: 6	Location: Northwest of SWMU 3
--------------	-------------------------------

Comments: Sample 6. Picture of augered hole facing west.

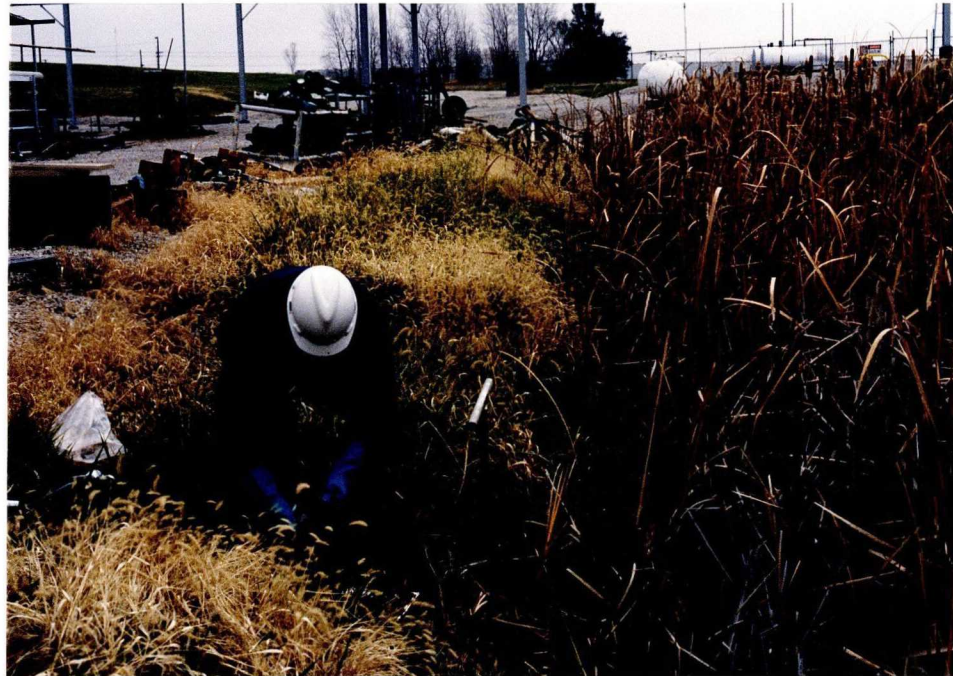
Photo No.: 11	Location: A SWMU 8
---------------	--------------------

Comments: Sample 11. Picture of sampling personnel with handheld auger facing east.

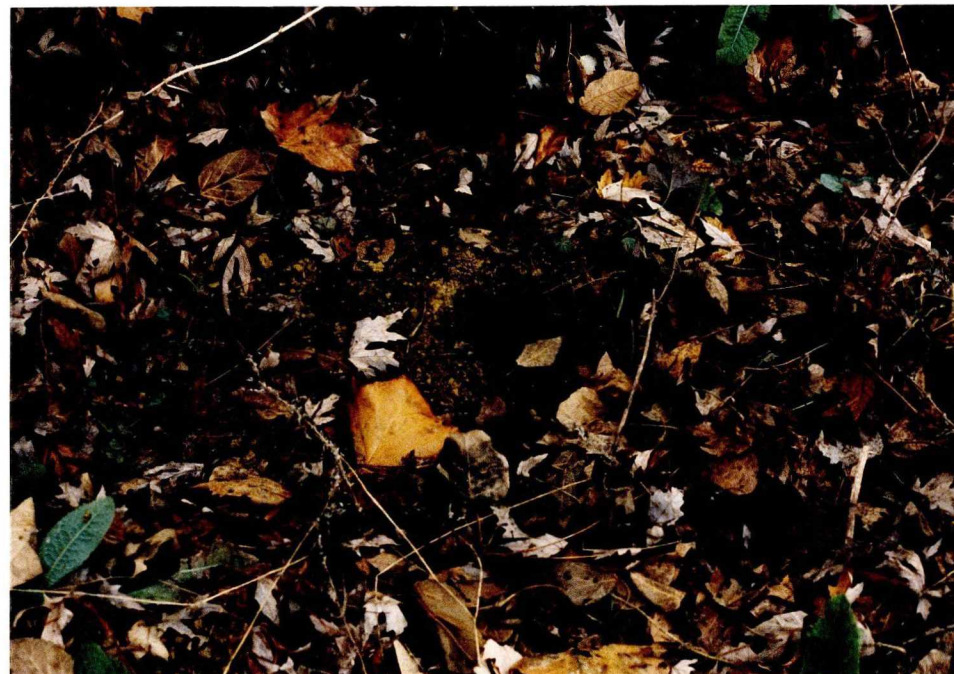
Photo No.: 12	Location: West of SWMU 9
---------------	--------------------------

Comments: Sample 12. Picture of augered hole facing south.

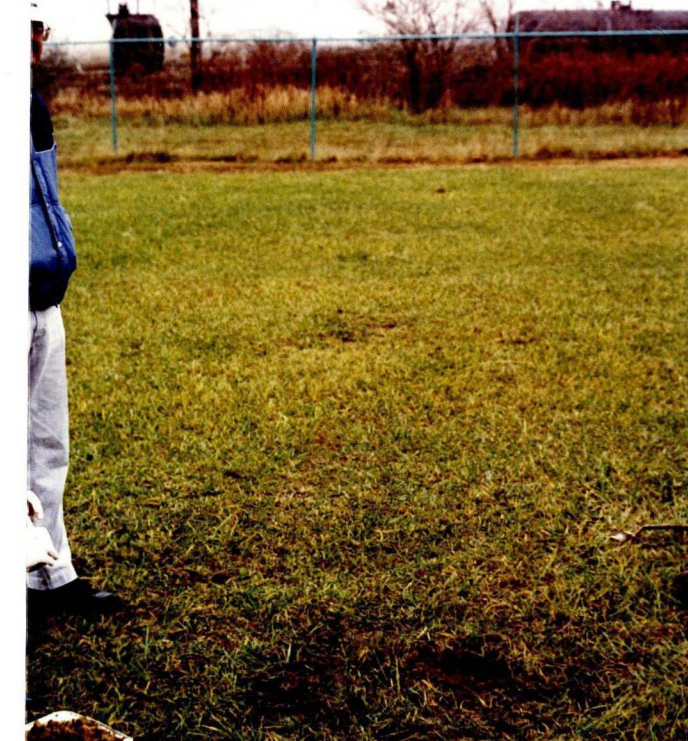
Photo No.: 9	Location: Northeast of SWMU 4
--------------	-------------------------------

Comments: Sample 9. Picture of augered hole facing east.

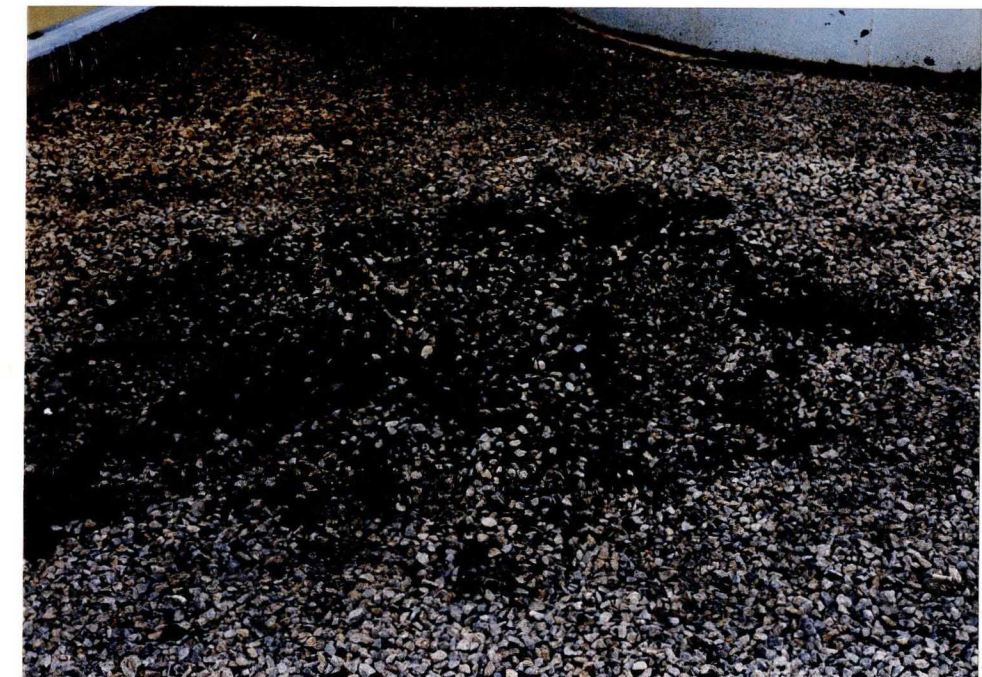
Photo No.: 10	Location: North of SWMU 6
---------------	---------------------------

Comments: Sample 10. Picture of augered hole facing north.

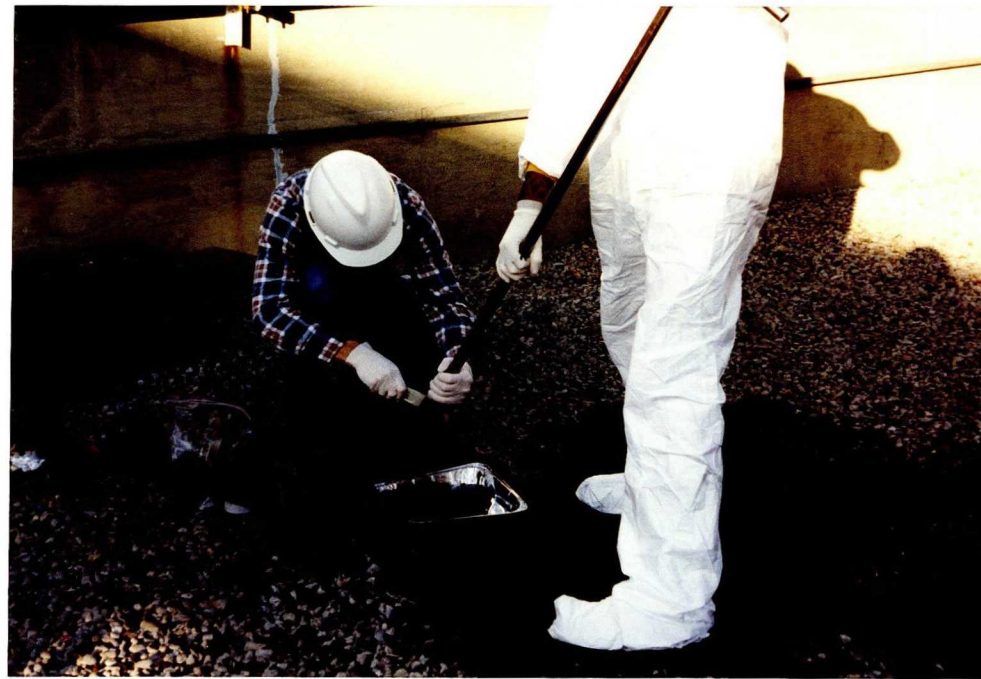
Photo No.: 3	Location: A SWMU 7
--------------	--------------------

Comments: Sample #5. Versar personnel removing soil from stainless steel auger.

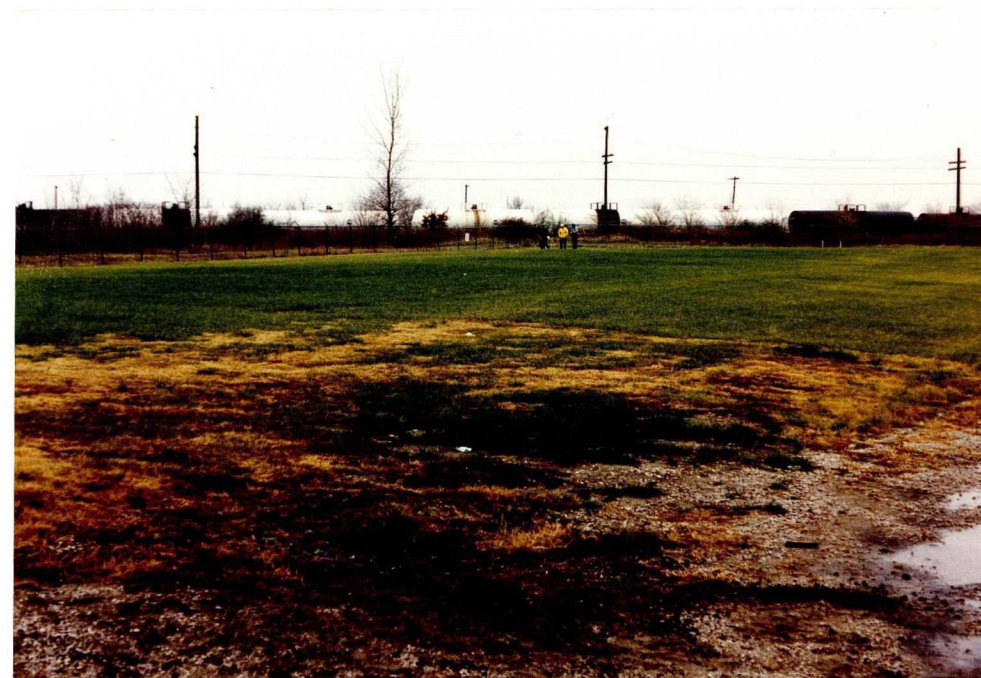
Photo No.: 4	Location: Southwest of SWMU 4
--------------	-------------------------------

Comments: Sample #8. General photo facing northeast; sampling personnel in background.

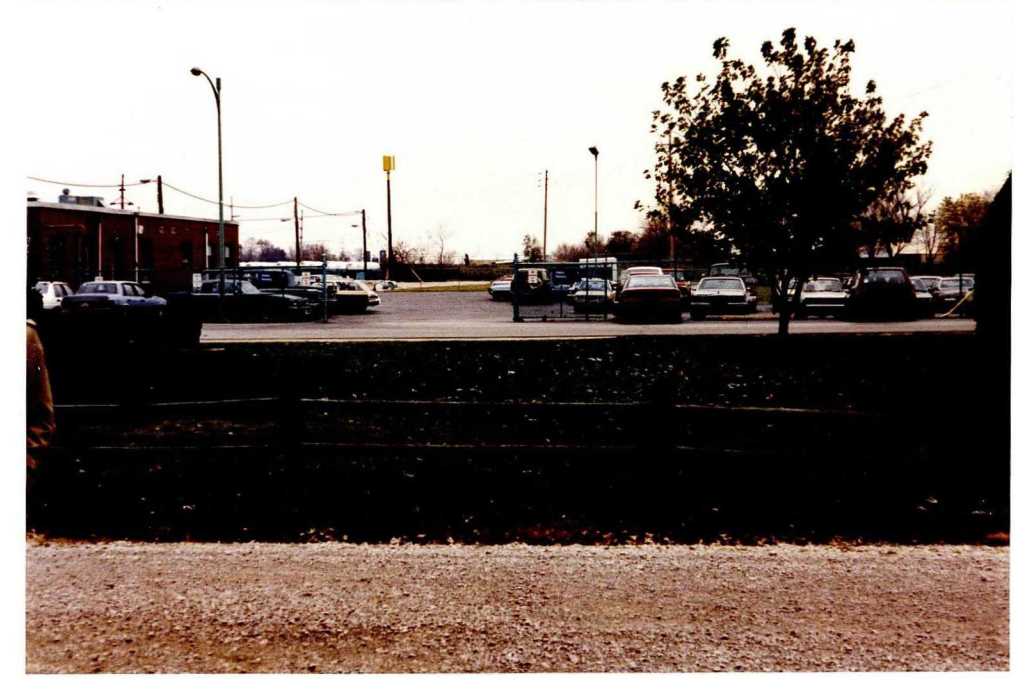
Photo No.: 1	Location: West of facility facing south
--------------	---

Comments: Photo taken after completing sample #1.

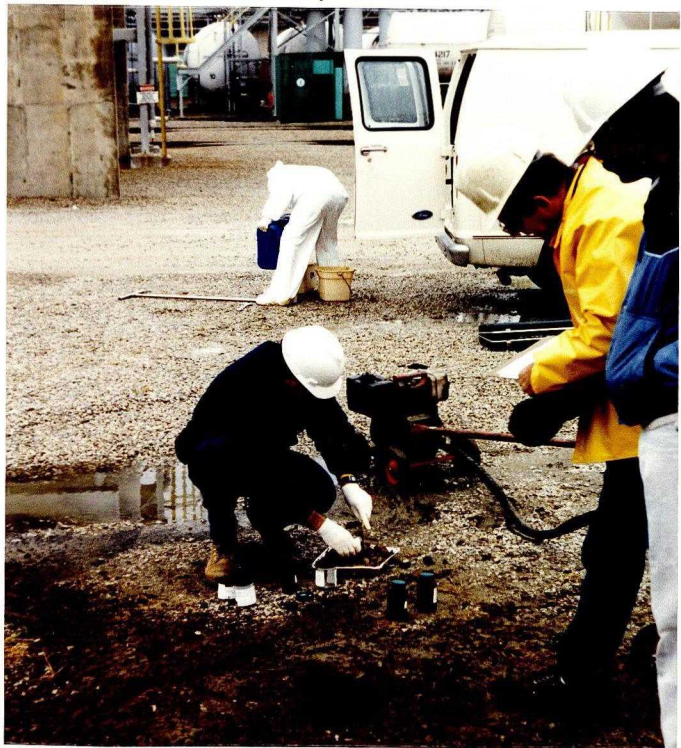
Photo No.: 5	Location: Southwest of SWMU 4
--------------	-------------------------------

Comments: Sample #8. Versar sampling personnel filling sampling jars with Allied-Signal personnel observing (right). Versar personnel decontaminating stainless steel auger (background).

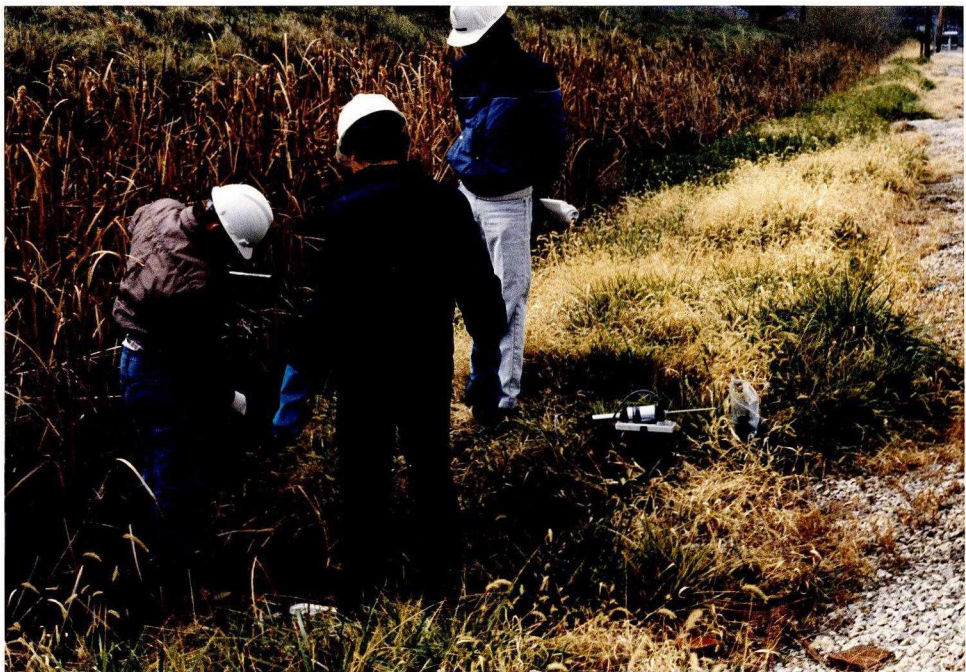
Photo No.: 6	Location: A SWMU 8
--------------	--------------------

Comments: Sample #11. Versar sampling personnel obtaining soil sample (foreground). HNu photoionization detector nearby. Allied-Signal representative observing (background).
